The Martian Landscape

By The Viking Lander Imaging Team

Scientific and Technical Information Office
NATIONAL AERONAUTICS AND SPACE ADMINISTRATION
Washington, D.C. 1978

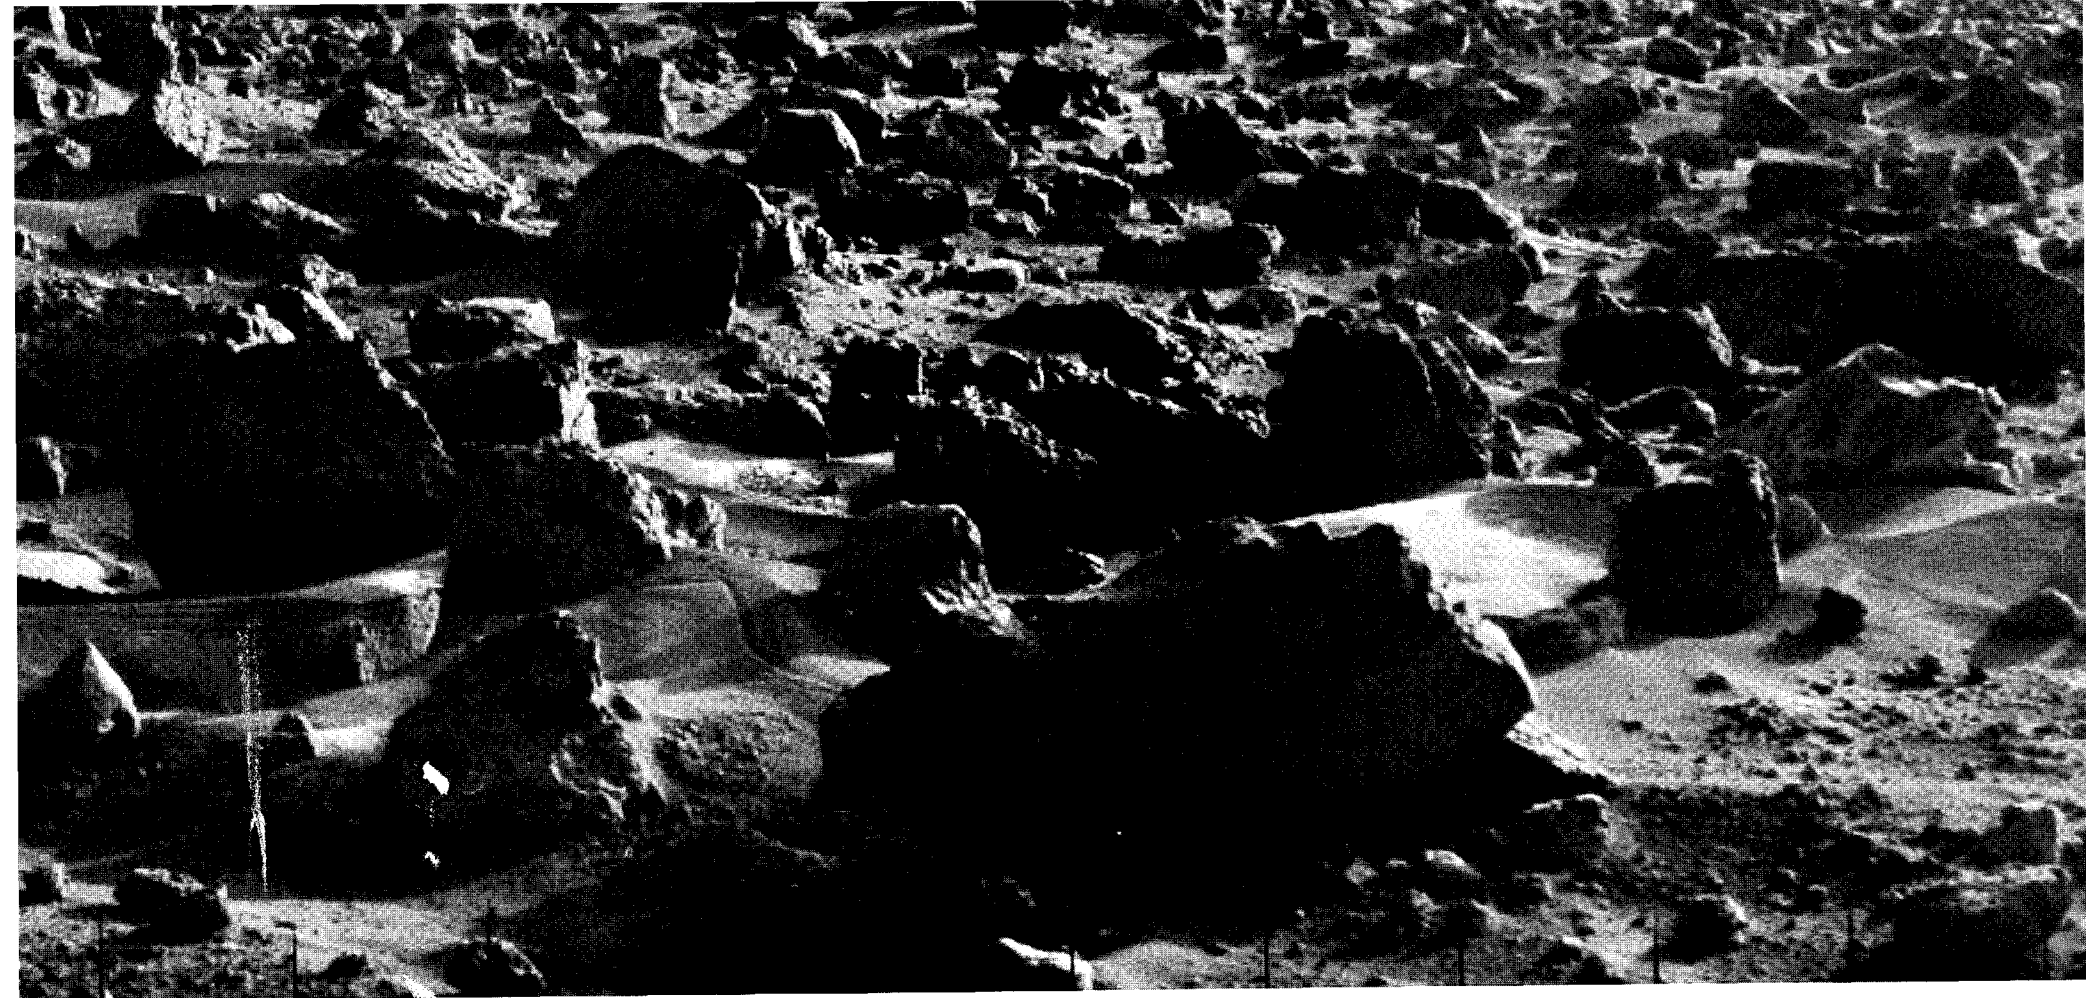
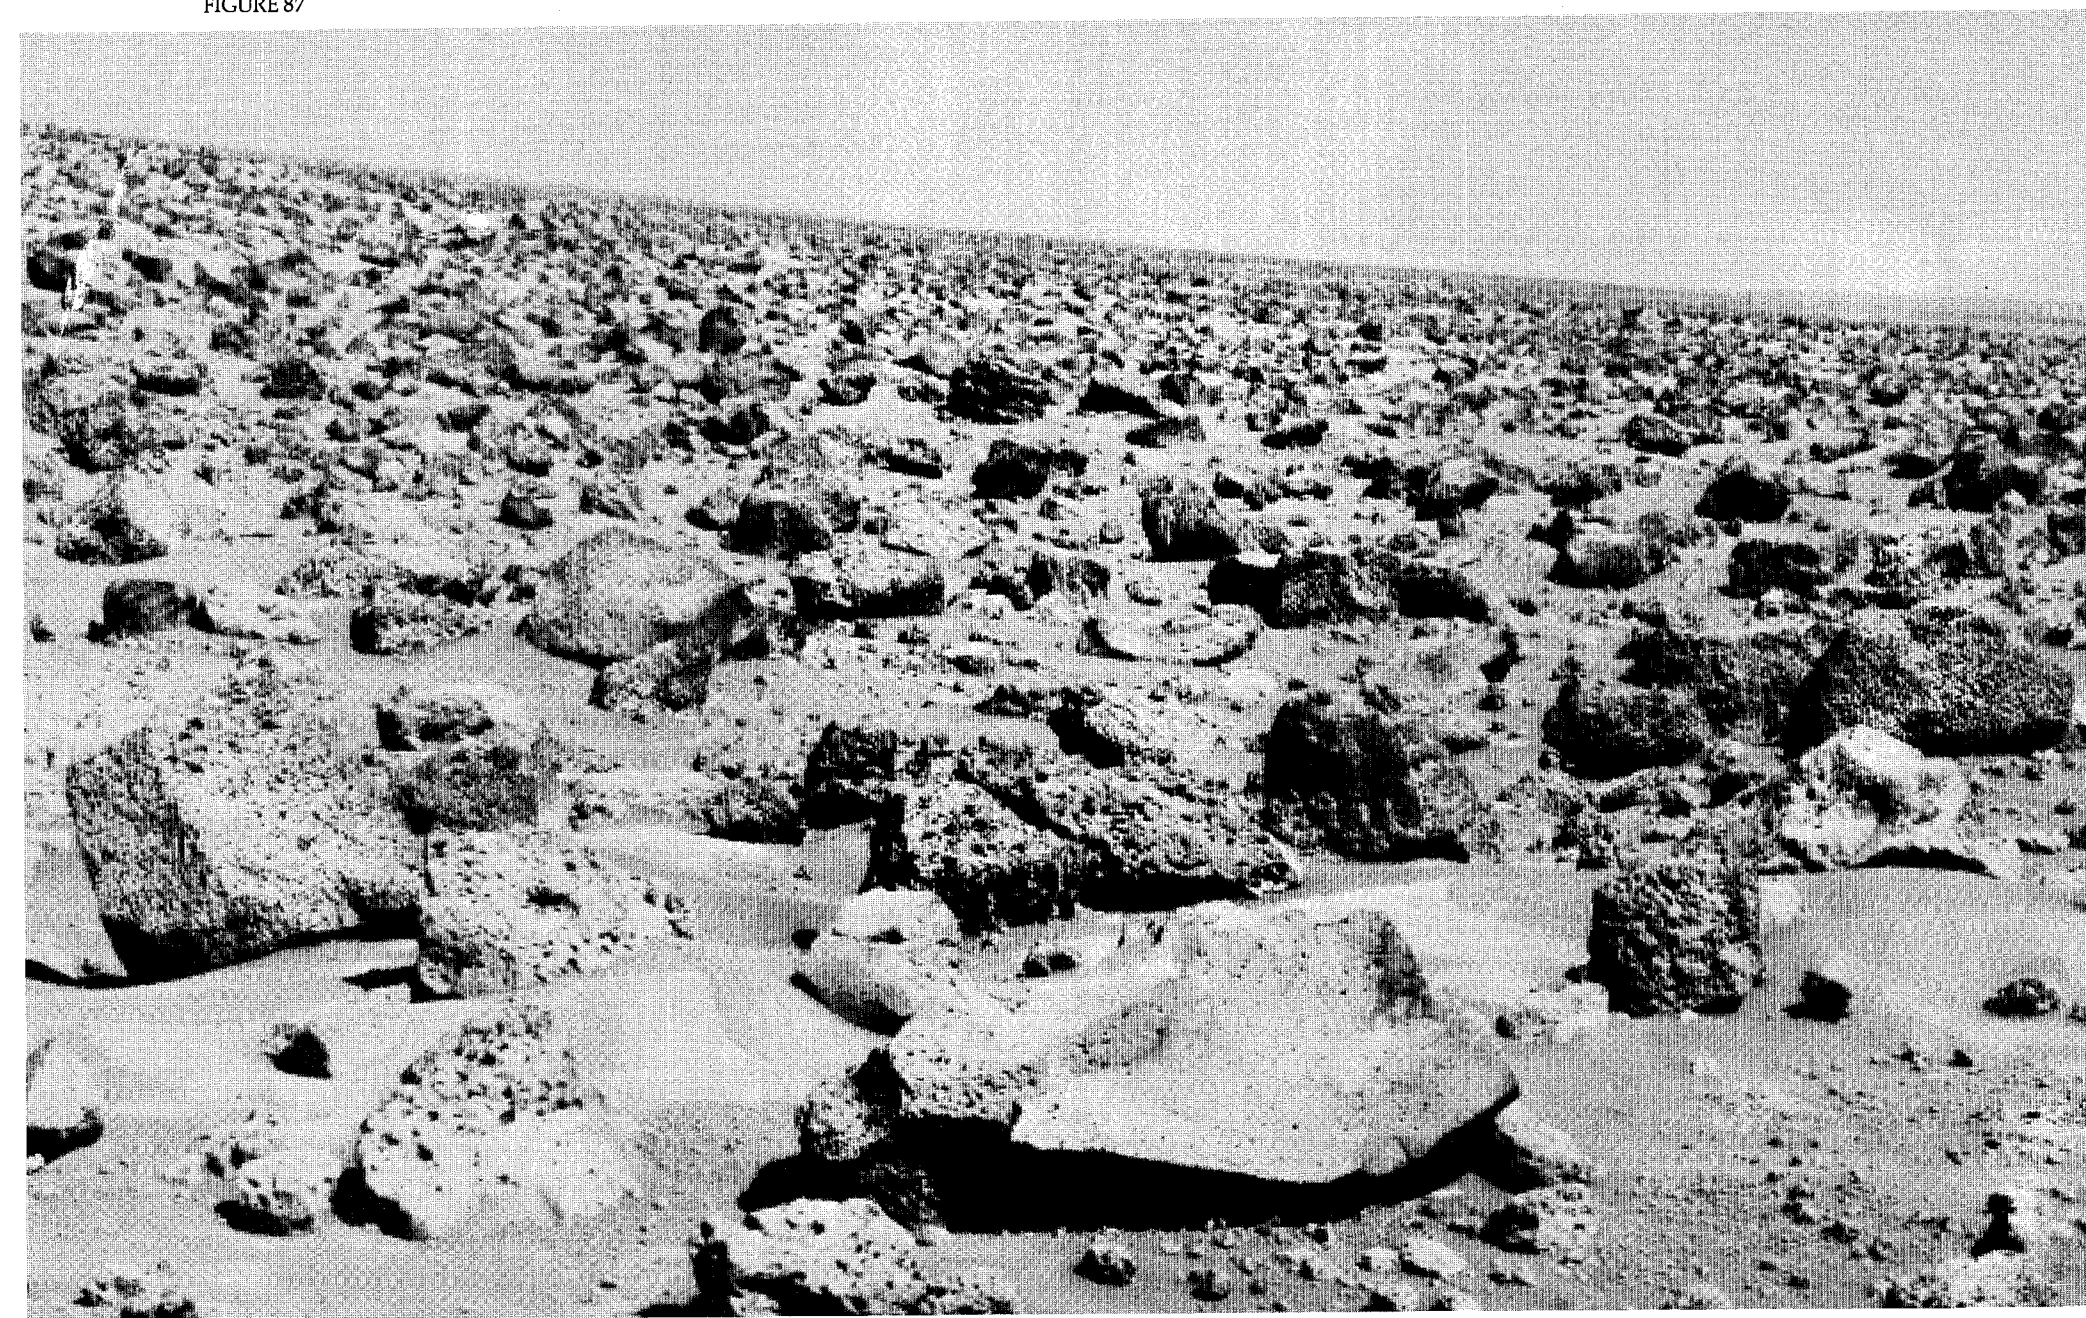
Figures 86 and 87 are two views of the same area in front of the spacecraft looking toward the north to northeast, both taken with camera 2 but at different times of day. Linear accumulations of fine-grained sediment have planar surfaces that are sharply delineated by shadow and reflected light. The small

pyramidal rock in the lower left is a good example of a ventifact, a rock with multiple facets eroded by the wind.

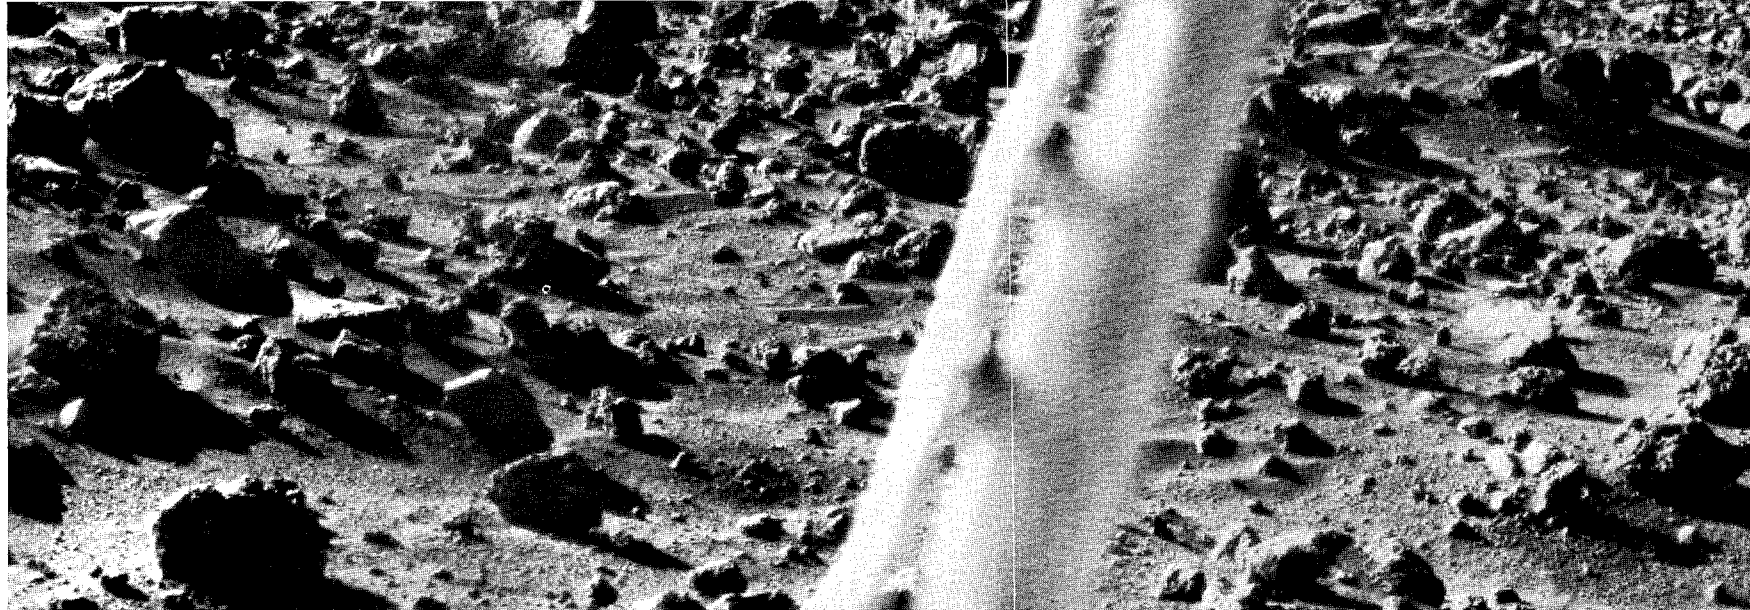
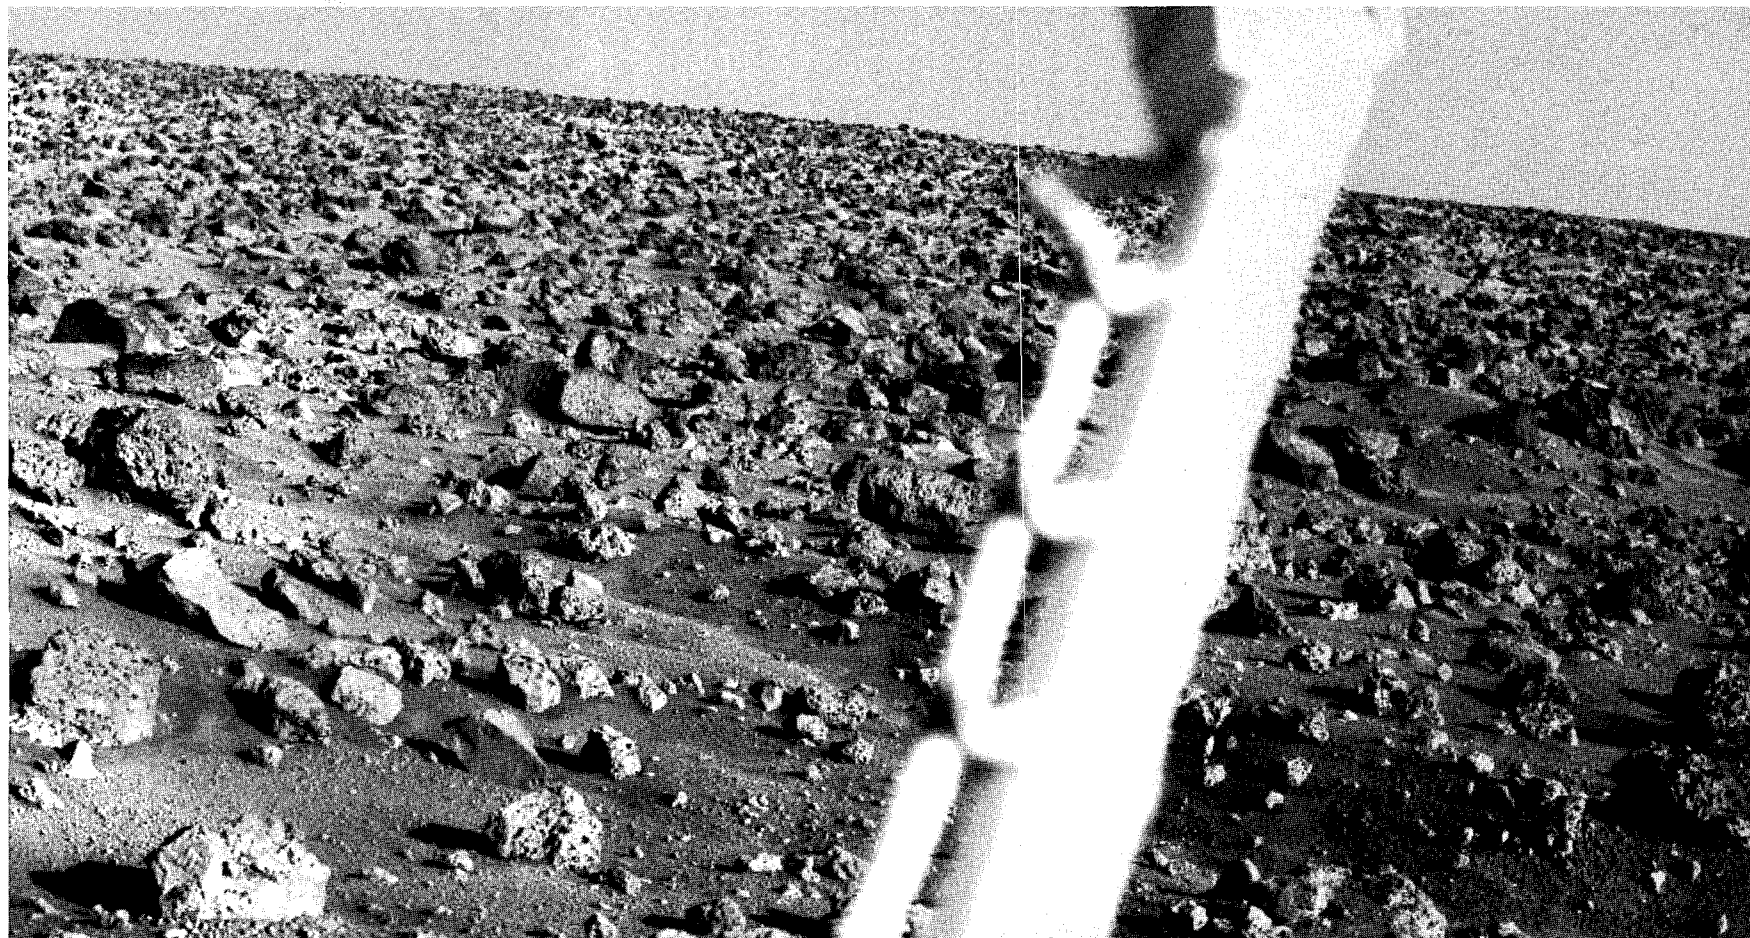
Figures 88 and 89 are two views of an area in front of the Lander taken with camera 1. The prominent spacecraft structure is the meteorology boom. Note the shallow trough, especially prominent

in figure 89, that can be traced down and to the right. Extending to the right of these pictures it becomes even more prominent, as in figure 100. Small crescent-shaped deposits of fine-grained material are visible along the entire length of the trough.

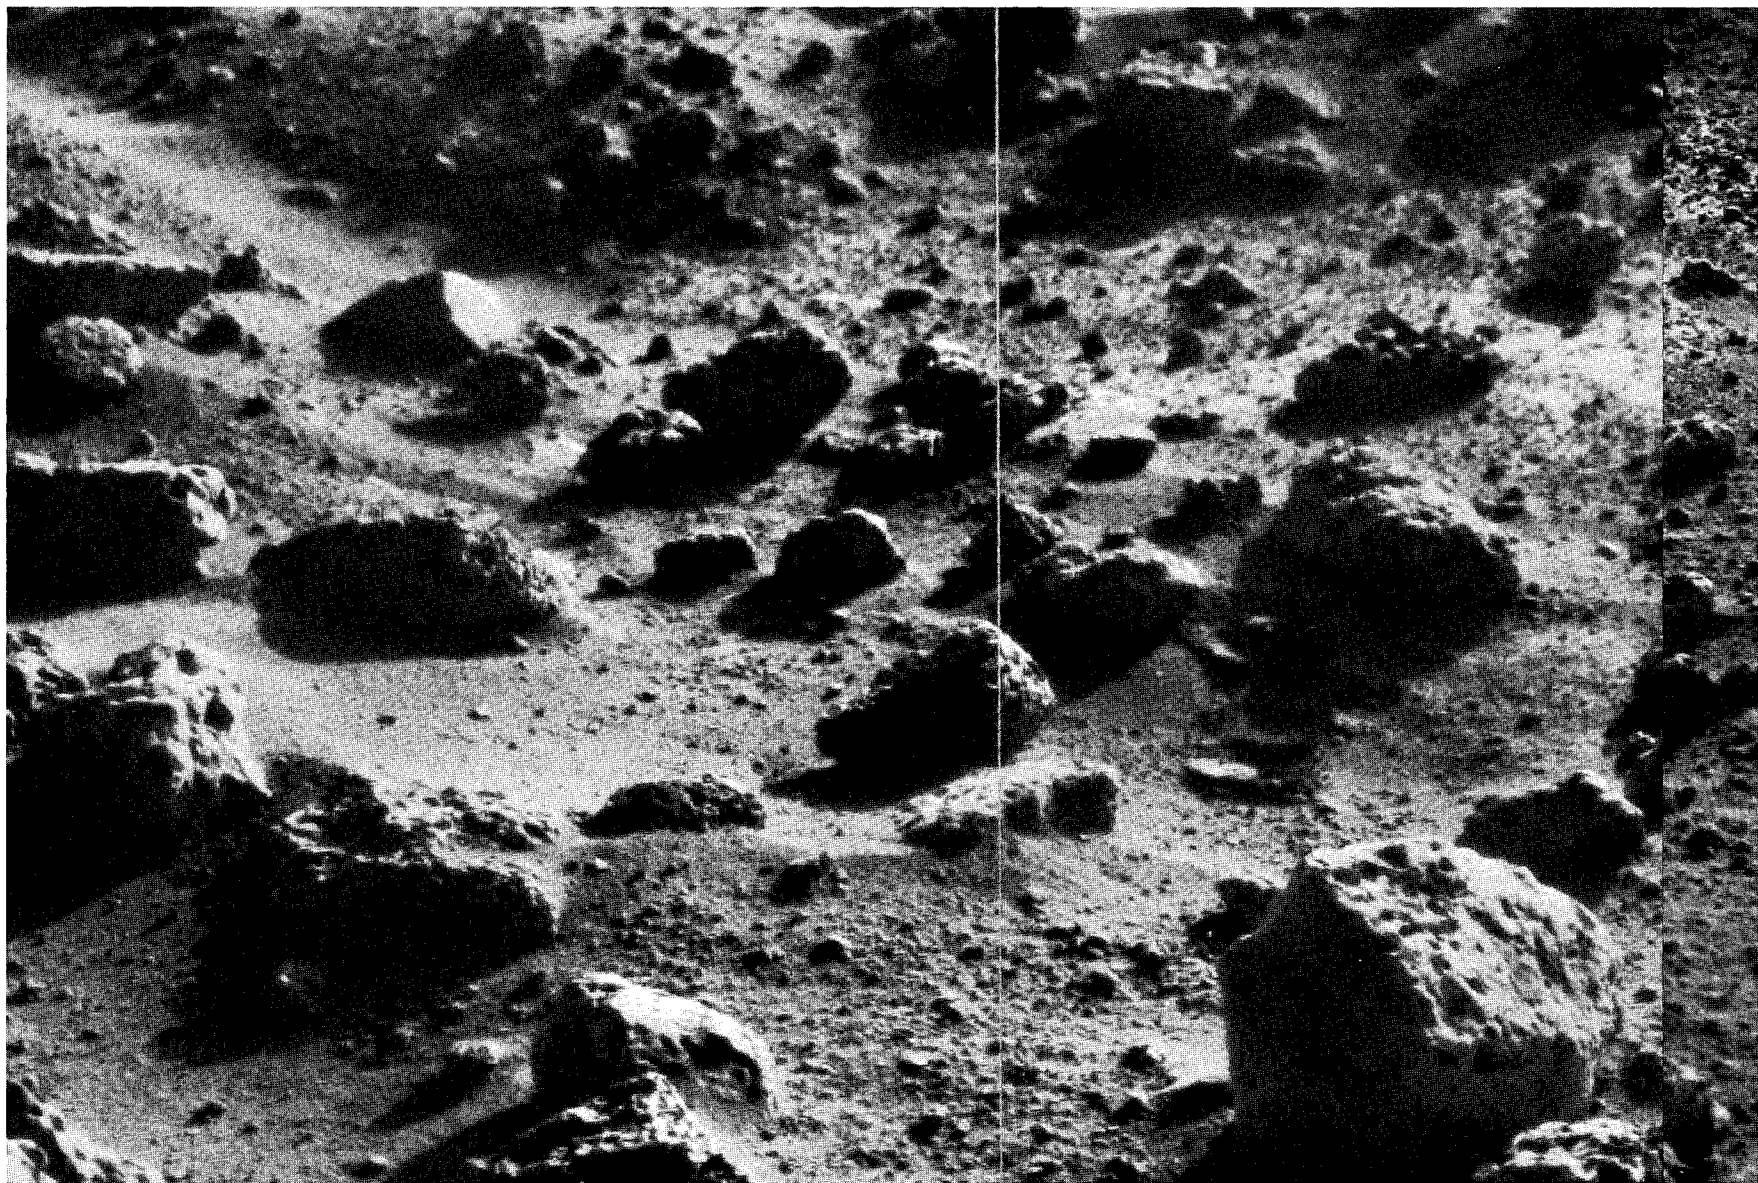
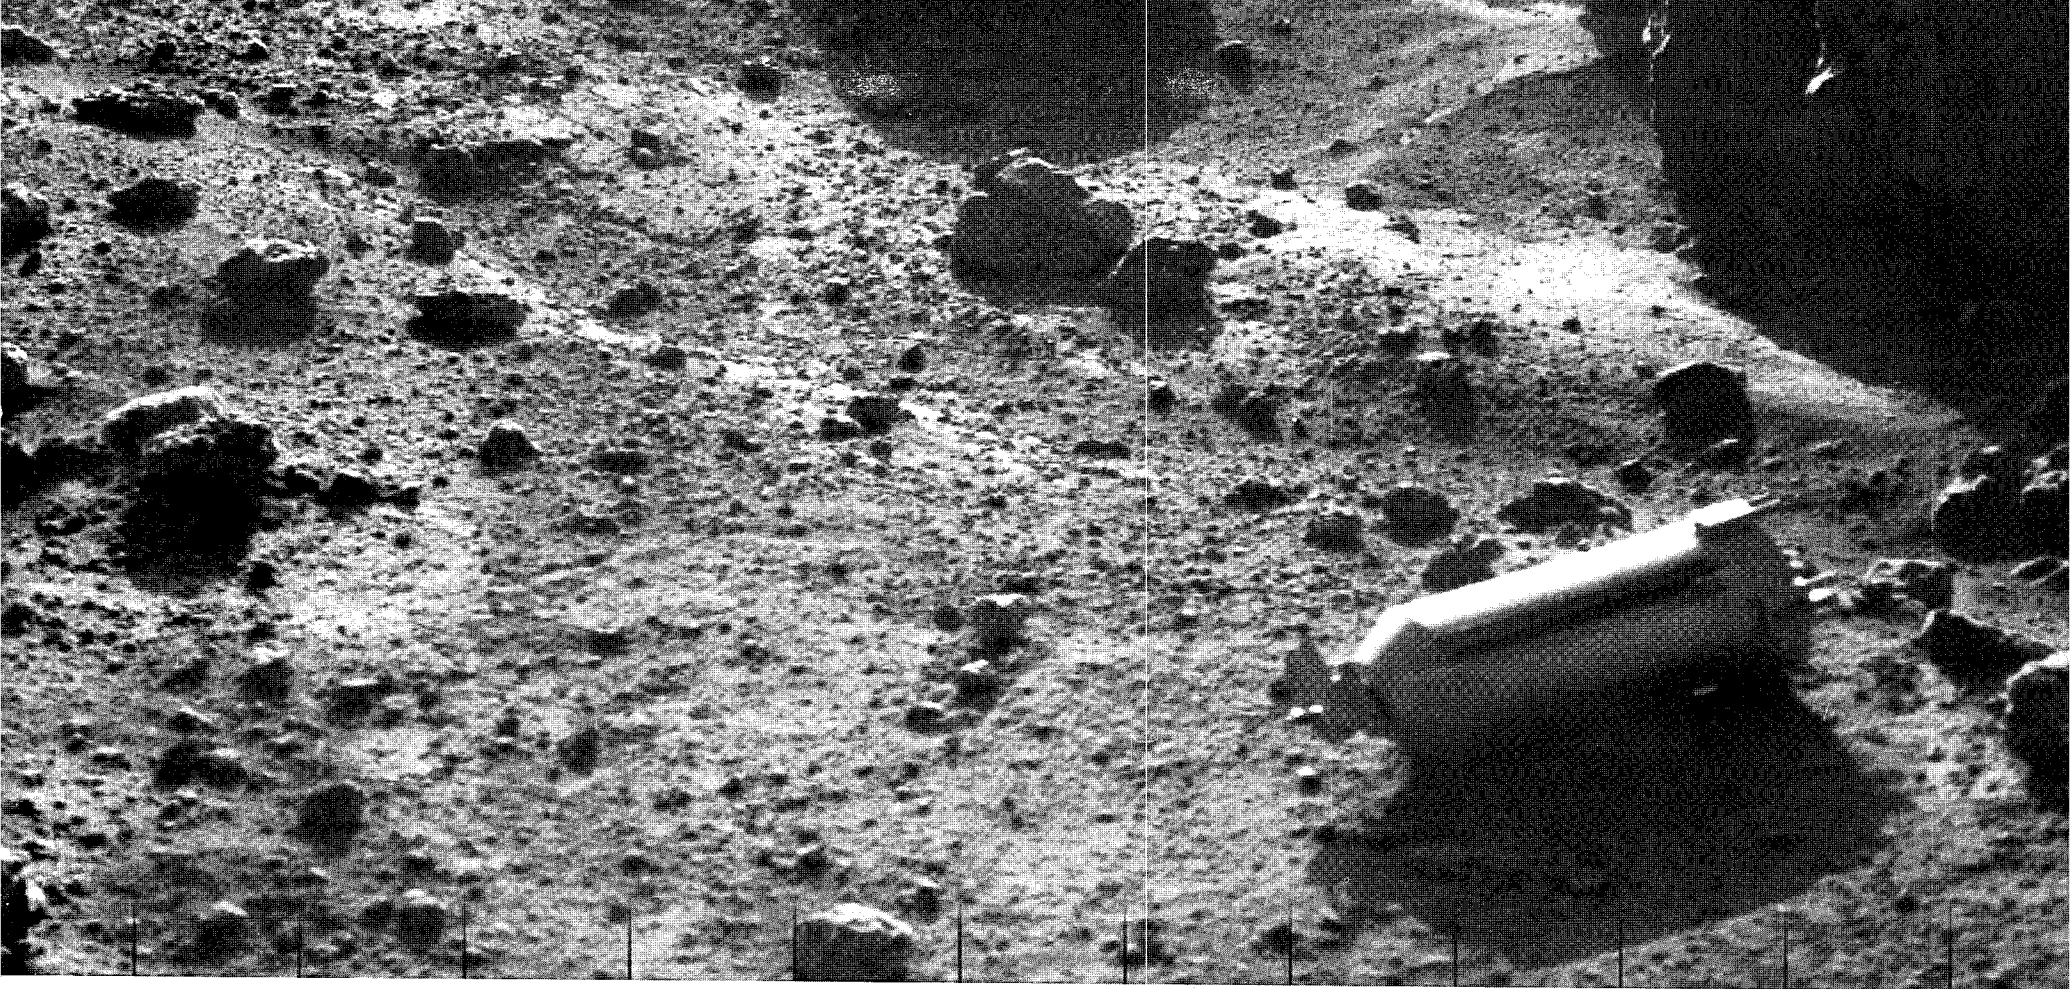
Figures 90 and 91 constitute a single panorama, taken in the early morning. The prominent cylindrical object in the lower right of figure 91 is a protective shroud that covered the surface sampler during transit to Mars. It was deployed the second day after landing. Its regular outline and brightly reflecting surfaces stand in vivid contrast to the natural scene.

The long early-morning shadows consistently extend to the west, but they appear to change direction as the perspective of the viewer changes around this 60° panorama.

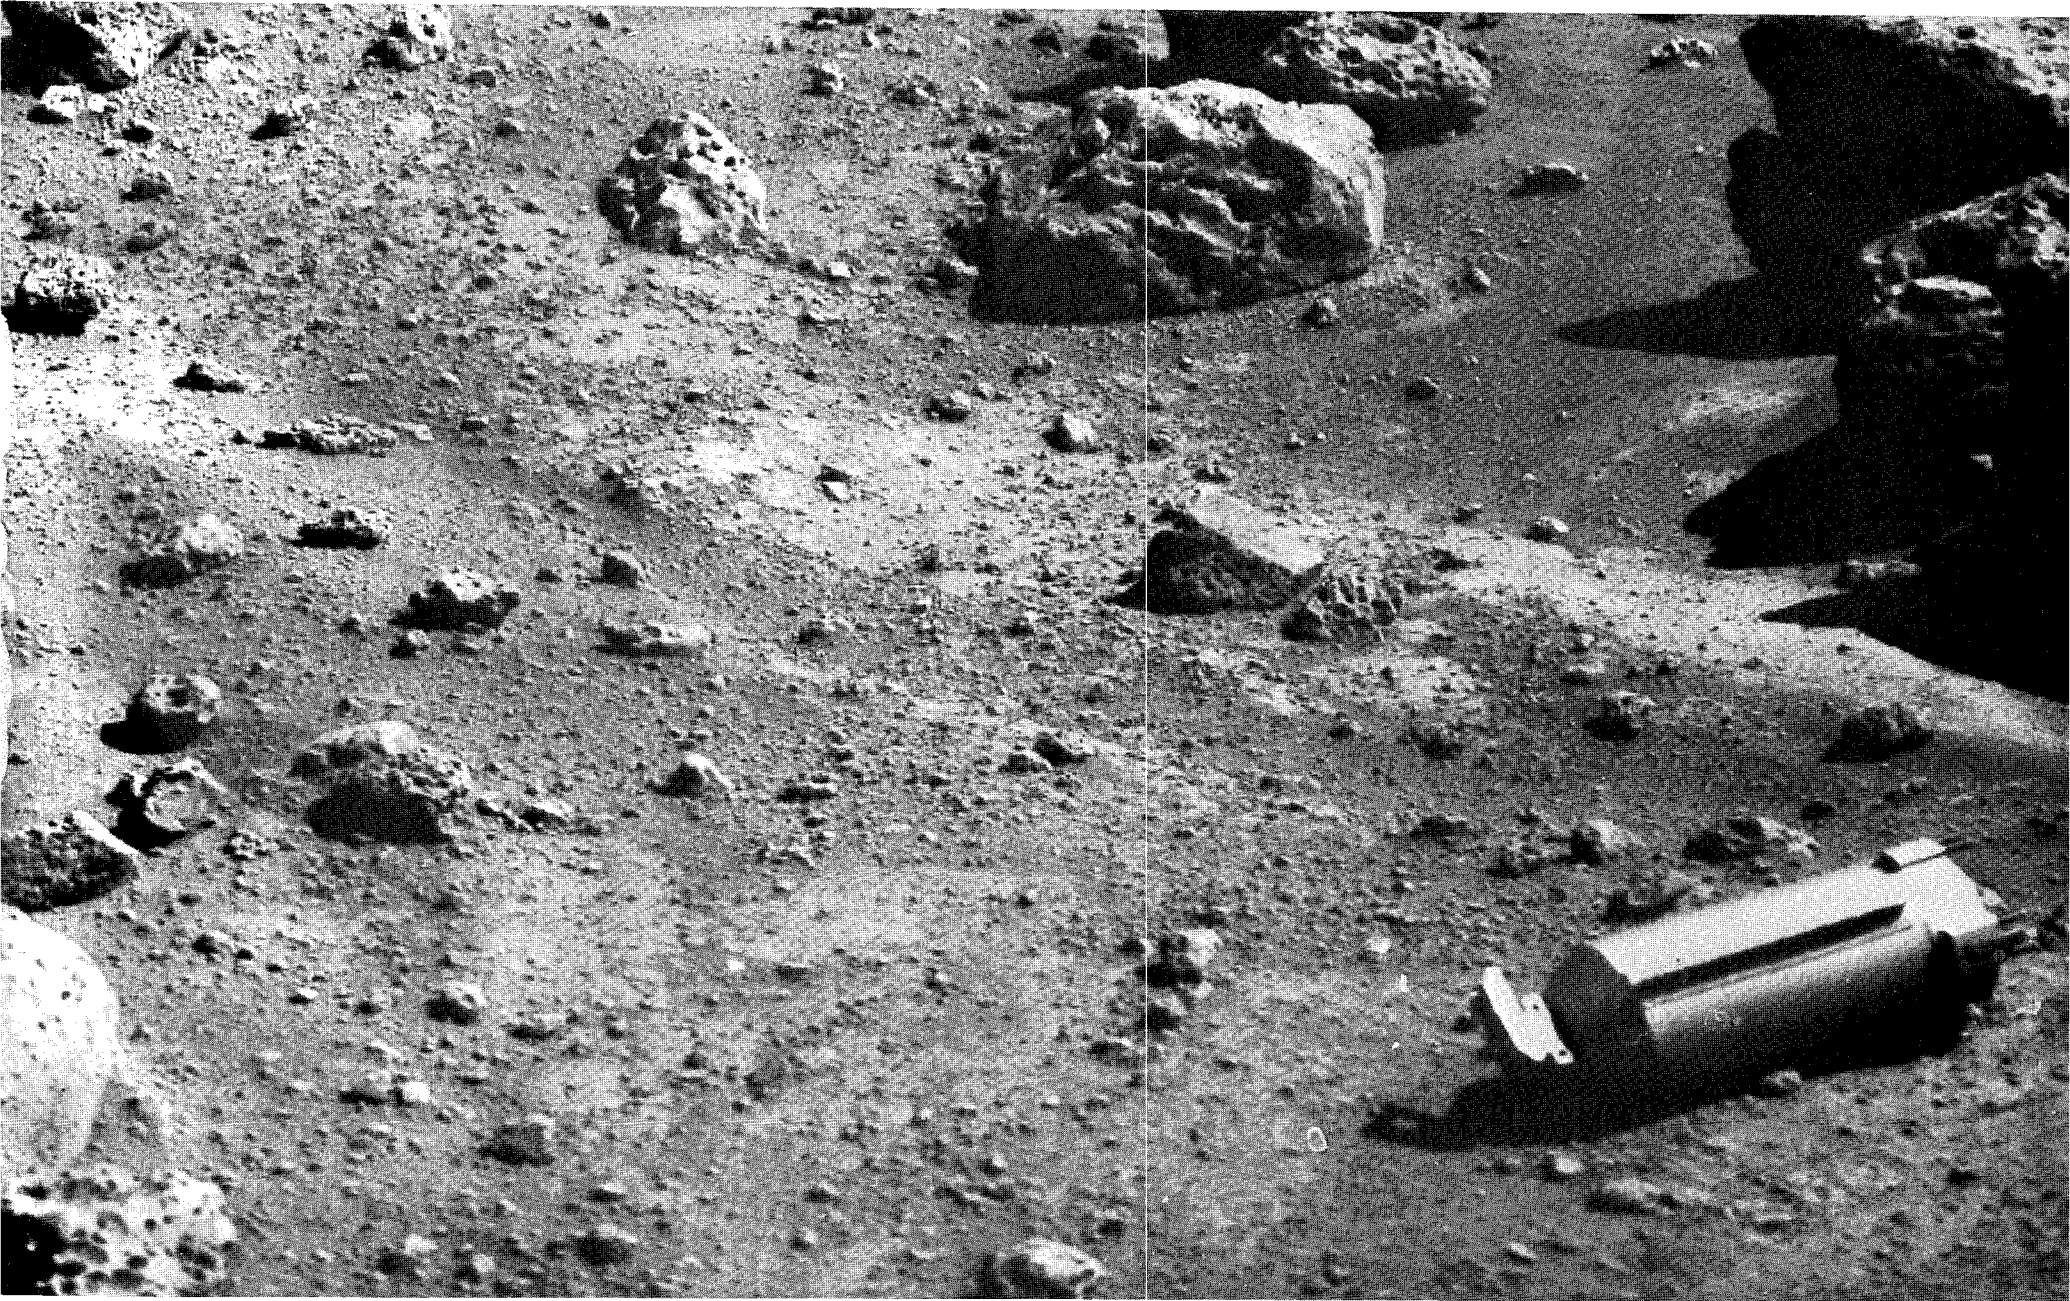
FIGURE 92

Figure 92 shows the area adjacent to the sampler shroud taken with high Sun illumination. The large rock at the top of the image exhibits an unusual scalloped surface, probably the result of wind erosion.

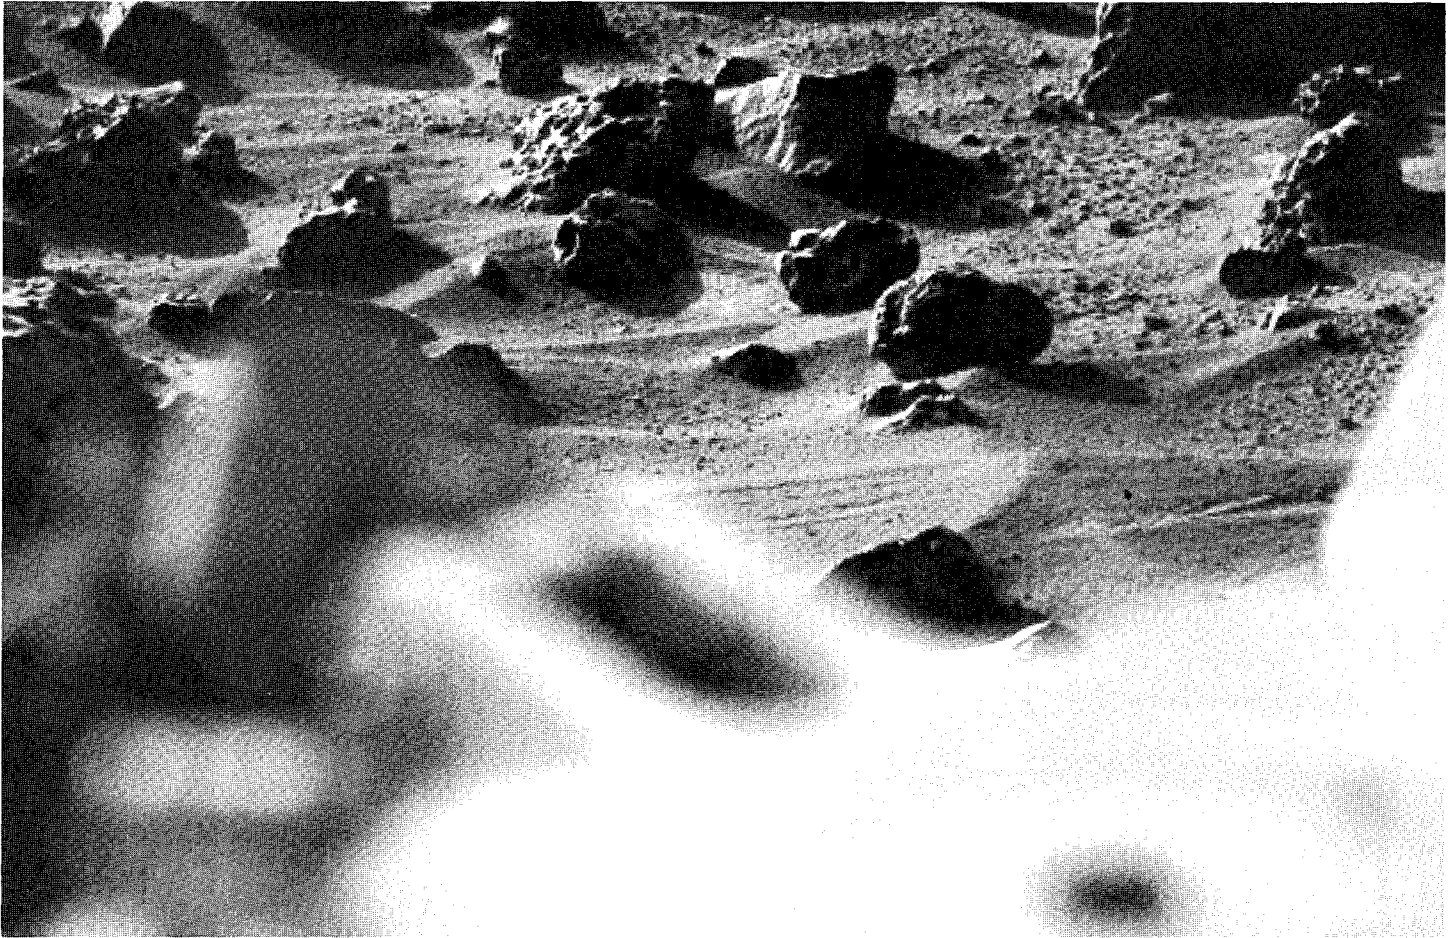
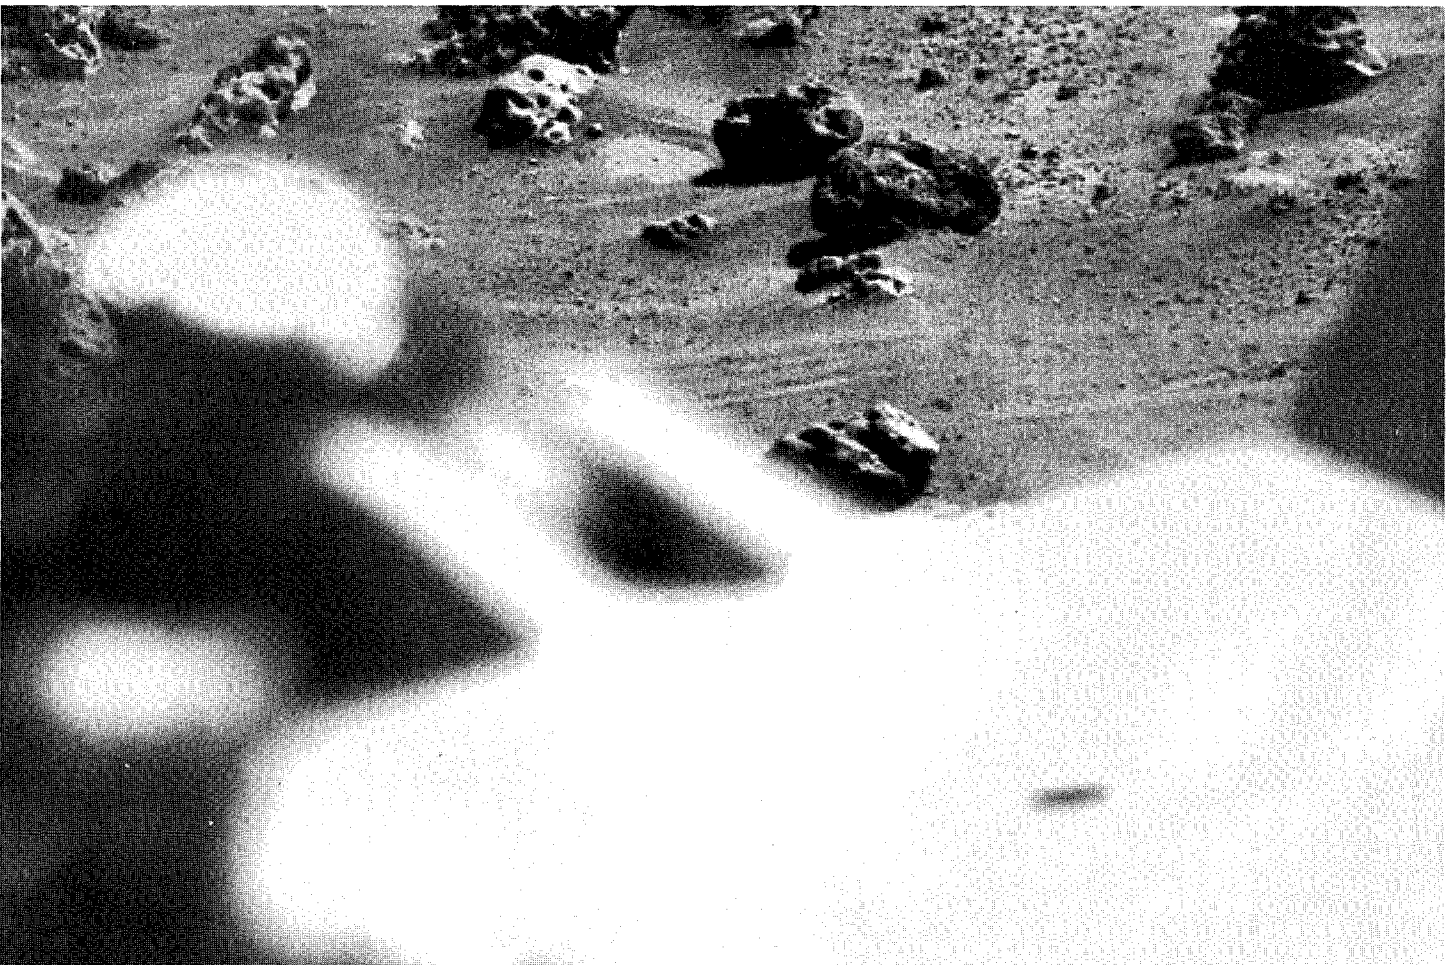
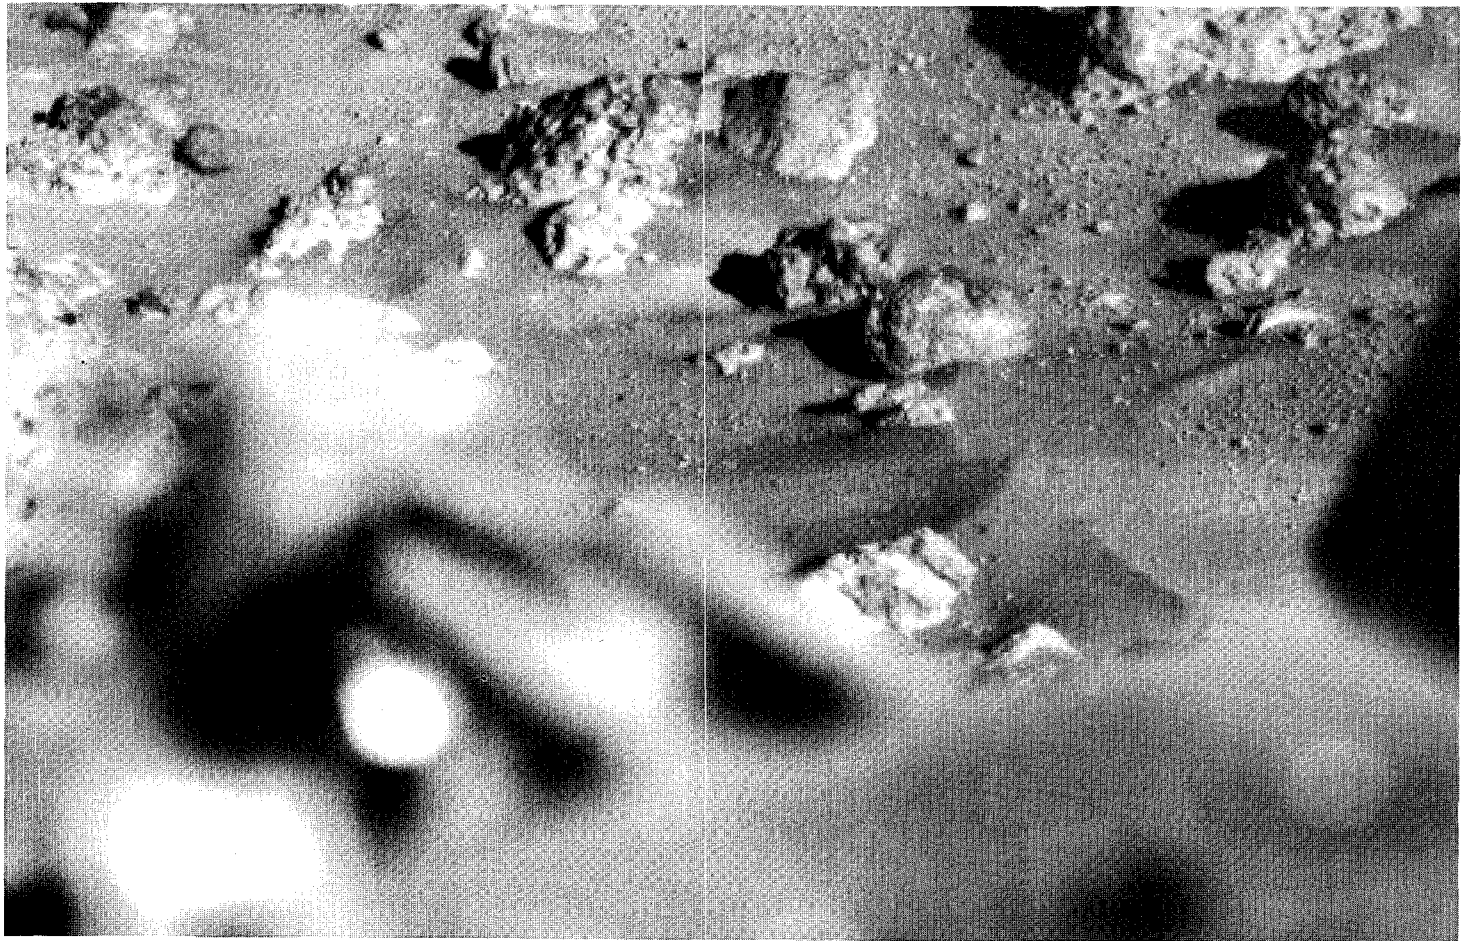
Figures 93, 94, and 95 show views of the surface, with the strut for leg 3 in the foreground, at three different times of day. Note the parallel lineation, probably due to wind scour. Small areas of duricrust appear near the top of the picture. Patches of coarse pebbles throughout the scene may result from removal of fine-grained material with attendant concentration of coarser particles.
